Flight Motor Set 360H005 (STS-28R) Final Report

**Volume V
(Nozzle Component)**

September 1990

***Thiokol* CORPORATION
SPACE OPERATIONS**

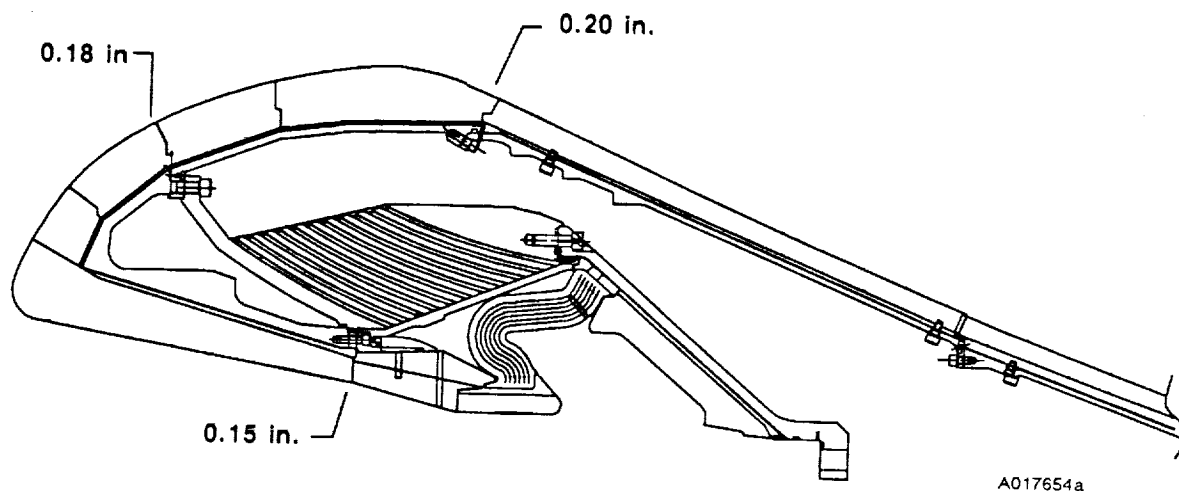
Figure 4 STS-28A Post-Flight Joint Flow Surface Gap Openings

Postflight subassembly flow surface gaps are shown in Figure 4. Overall views of the nozzle are shown in Figures 5 through 7.

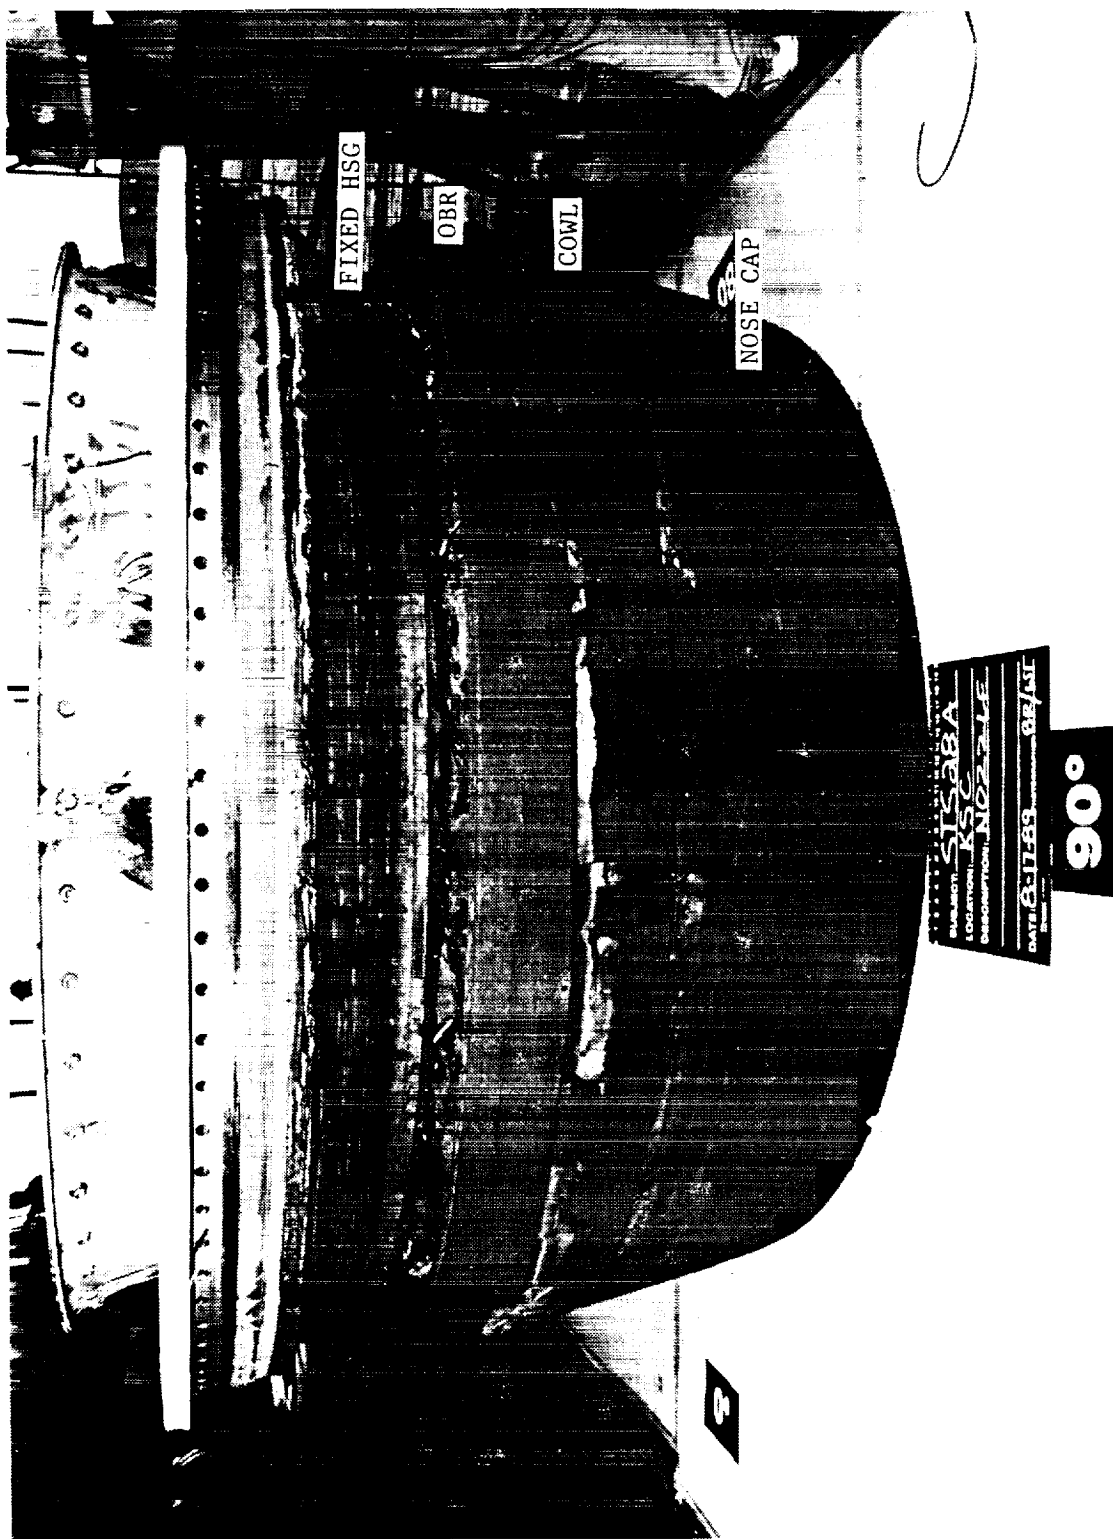
Figure 5 STS-28A Forward Nozzle Assy (External) 0-to-90-to-180 degrees

The fixed housing insulation erosion was smooth and uniform (see Figures 5 and 6). Postburn wedgeouts of charred CCP material were observed on the forward 2 inches intermittently around the circumference. The maximum radial depth of these wedgeouts was 0.5 inch. There was no heat effect to the GCP.

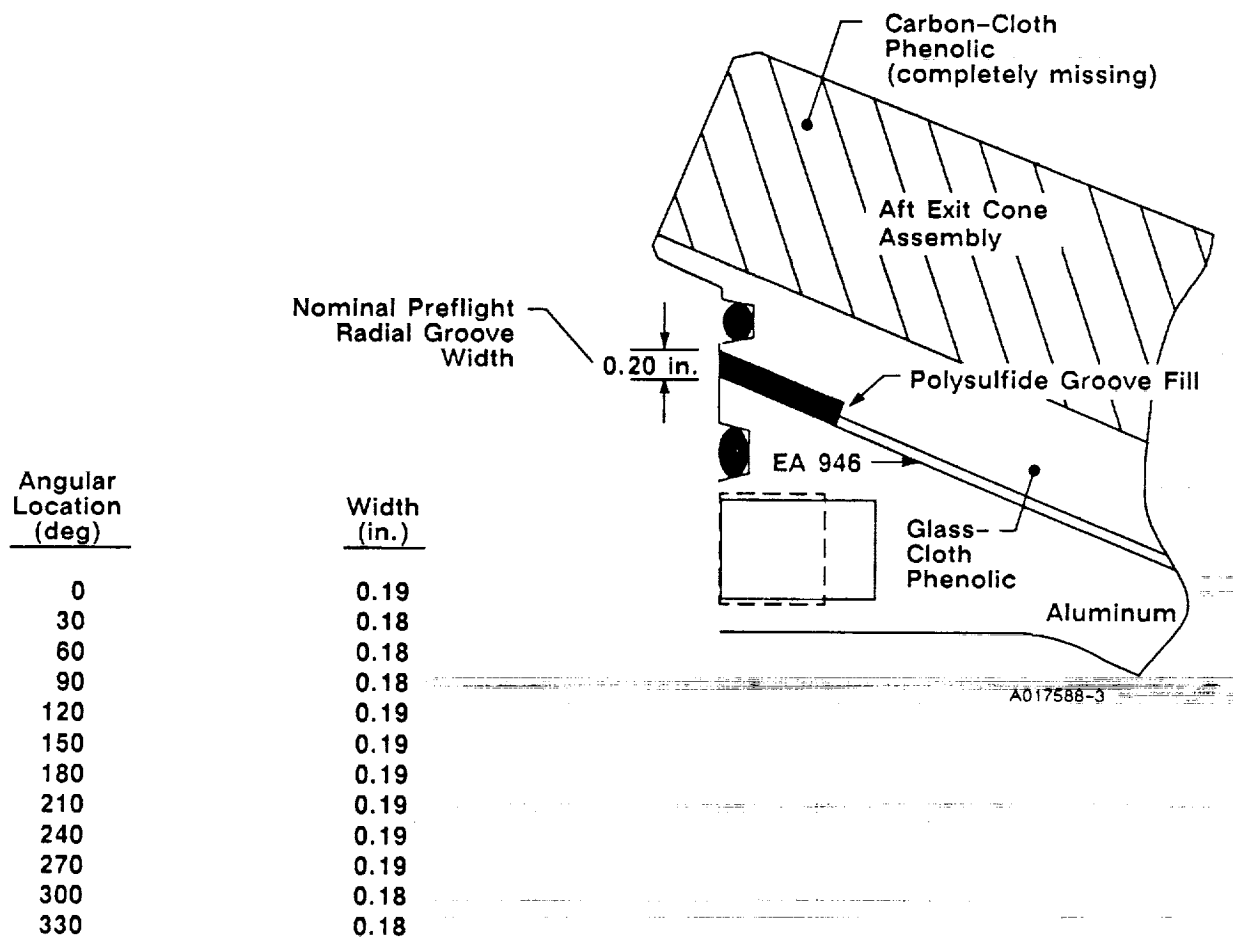
Figure 8. STS-28A Forward Exit Cone Bondline Separations

width), and 340-to-345 degrees (0.010 inch maximum radial width). Figure 8 lists the location and radial width measurements of all separations on the forward exit cone. These separations are typical observations which have been seen on previous static test and flight nozzles, and have been shown to occur postburn.

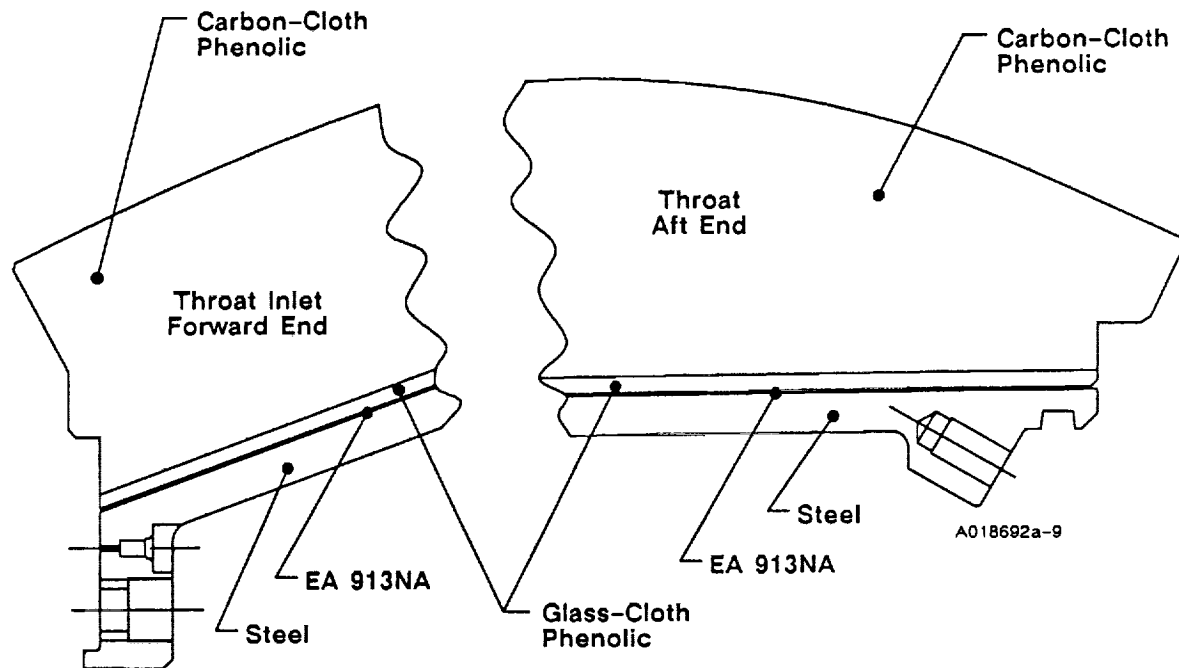
Figure 14 STS-28A Throat Assembly Bondline Separations

Bondline separations between the EA913 NA adhesive and the steel throat support housing were observed on the aft end 360 degrees circumferentially. The maximum radial width of these separations was 0.040 inch. Metal-to-adhesive bondline separations measuring 0.01-to-0.03 inch wide radially were observed on the forward end of the throat assembly circumferentially except at 75-to-105, 165-to-180, and 270-to-330 degrees. Figure 14 lists the location and radial width measurements of all separations on the throat assembly. These separations are typical observations which have been seen on previous static test and flight nozzles and have been shown to occur postburn.

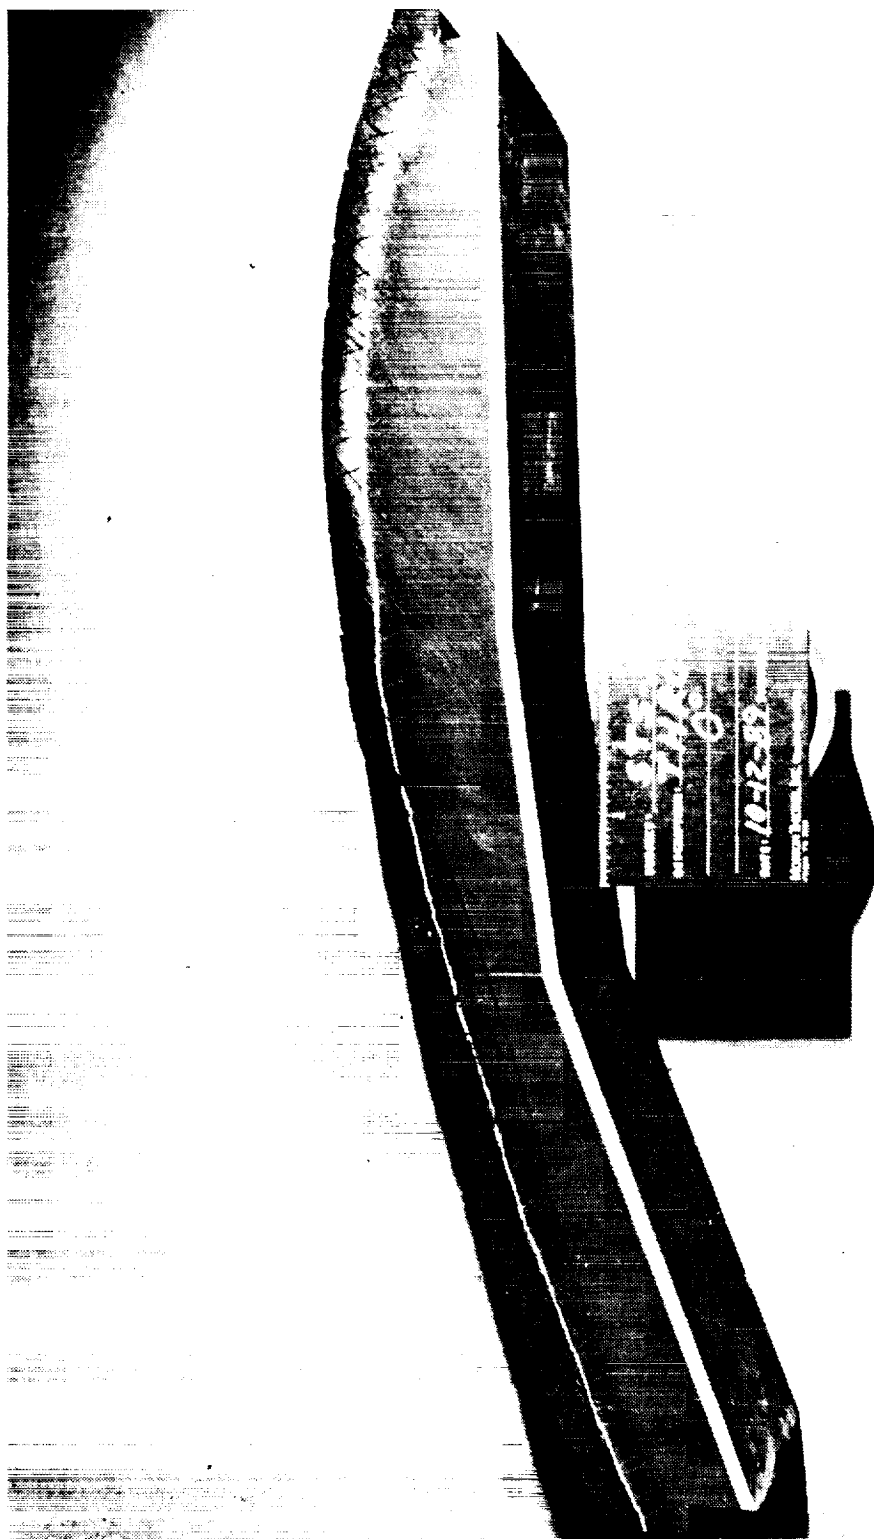
Figure 15 STS-28A Throat/Throat Inlet Section (0 deg)

Photographs of the sectioned throat assembly liner are presented in Figures 15 through 18. Char and erosion analysis of the sections is presented in Table 3. Figure 19 shows the location of the measurement stations. All margins of safety were positive, with a minimum of 0.03 occurring at station 8 (90 degrees).

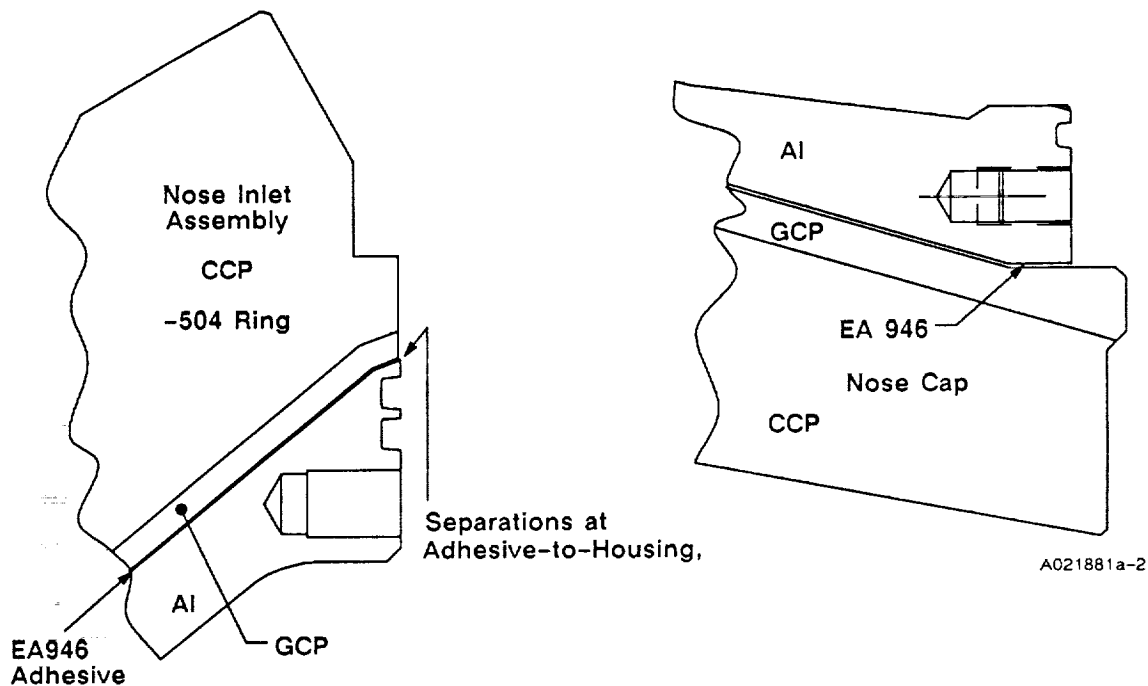
Figure 20 STS-28A Nose Inlet Assy Bondline Separations

The aft end of the nose inlet assembly (-504 ring aft end) showed metal to adhesive bondline separations (0.01 inch maximum radial width) occurring intermittently around the circumference. Figure 20 lists the location and radial width measurements of all separations on the nose inlet assembly. These separations are typical observations seen on previous static test and flight nozzles and have been shown to occur postburn. No separations occurred at the aft end of the nose cap.

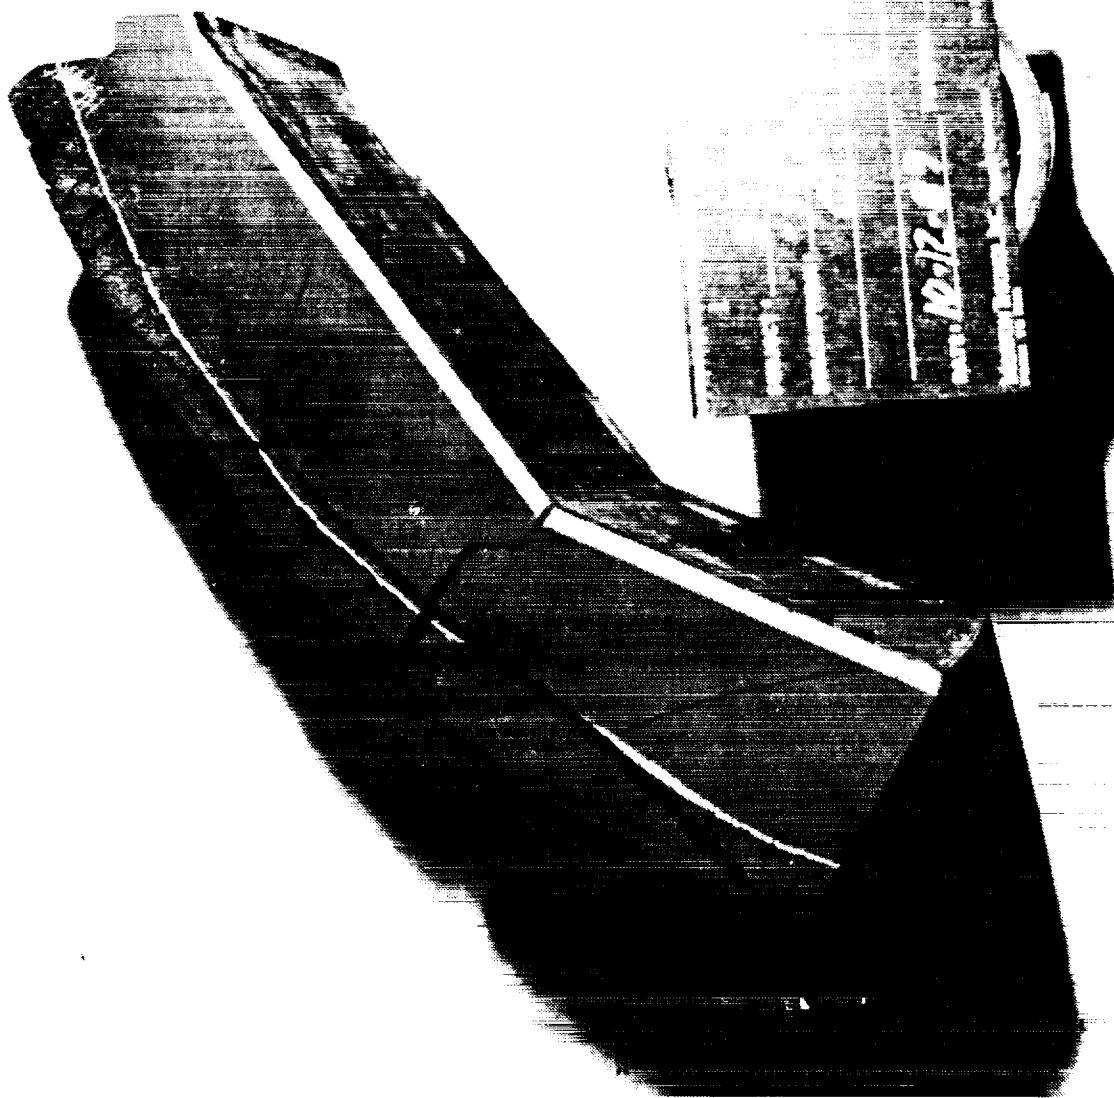
Figure 21 STS-28A Forward Nose Ring and Aft Inlet Ring (-503 and -504) Section (0 deg)

Photographs of the sectioned nose inlet assembly rings are presented in Figures 21 through 28. Char and erosion analysis of the sections is presented in Tables 4 and 5. All margins of safety were positive, with a minimum of 0.15 occurring at station 32 (270 degrees) for the -503/-504 rings, and 0.03 occurring at station 24 (90 degrees) for the nose cap. Figure 29 shows the nose inlet assembly erosion measurement stations.

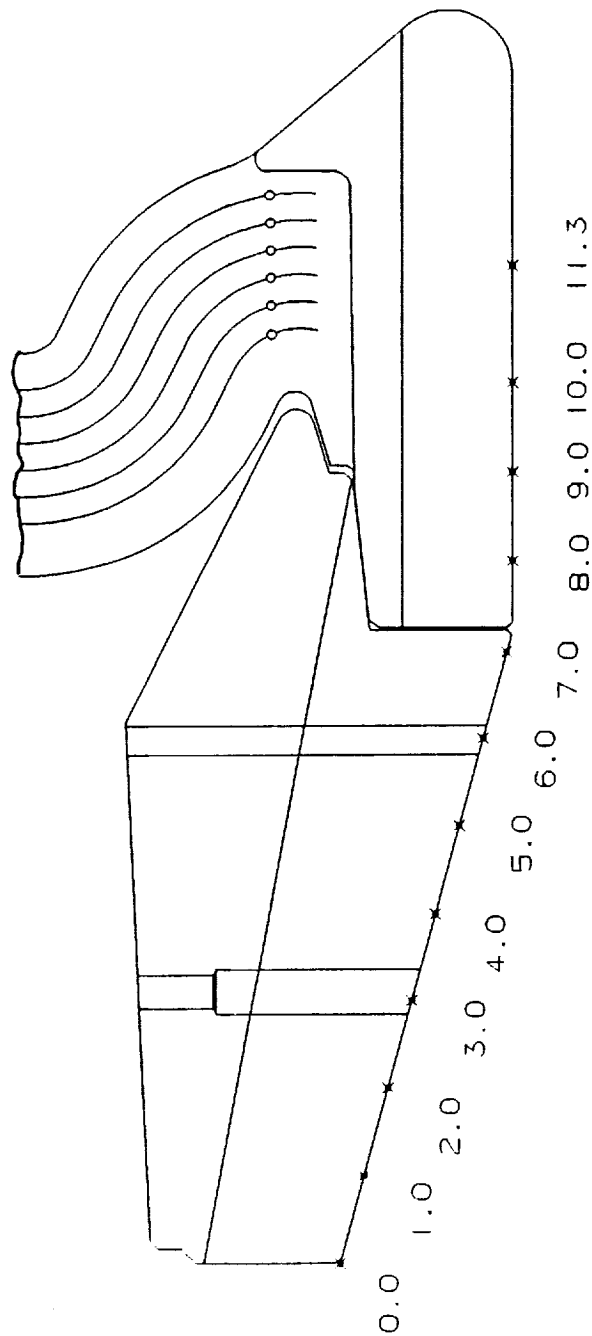
Figure 38 STS-28A Cowl Ring and Outer B0ot Ring Erosion Measurement Stations

Char and erosion analysis of the sections is presented in Table 6 (Stations 0 through 7). Figure 38 shows the location of the measurement stations. All margins of safety were positive, with a minimum of 0.25 occurring at station 2 (0 degrees).

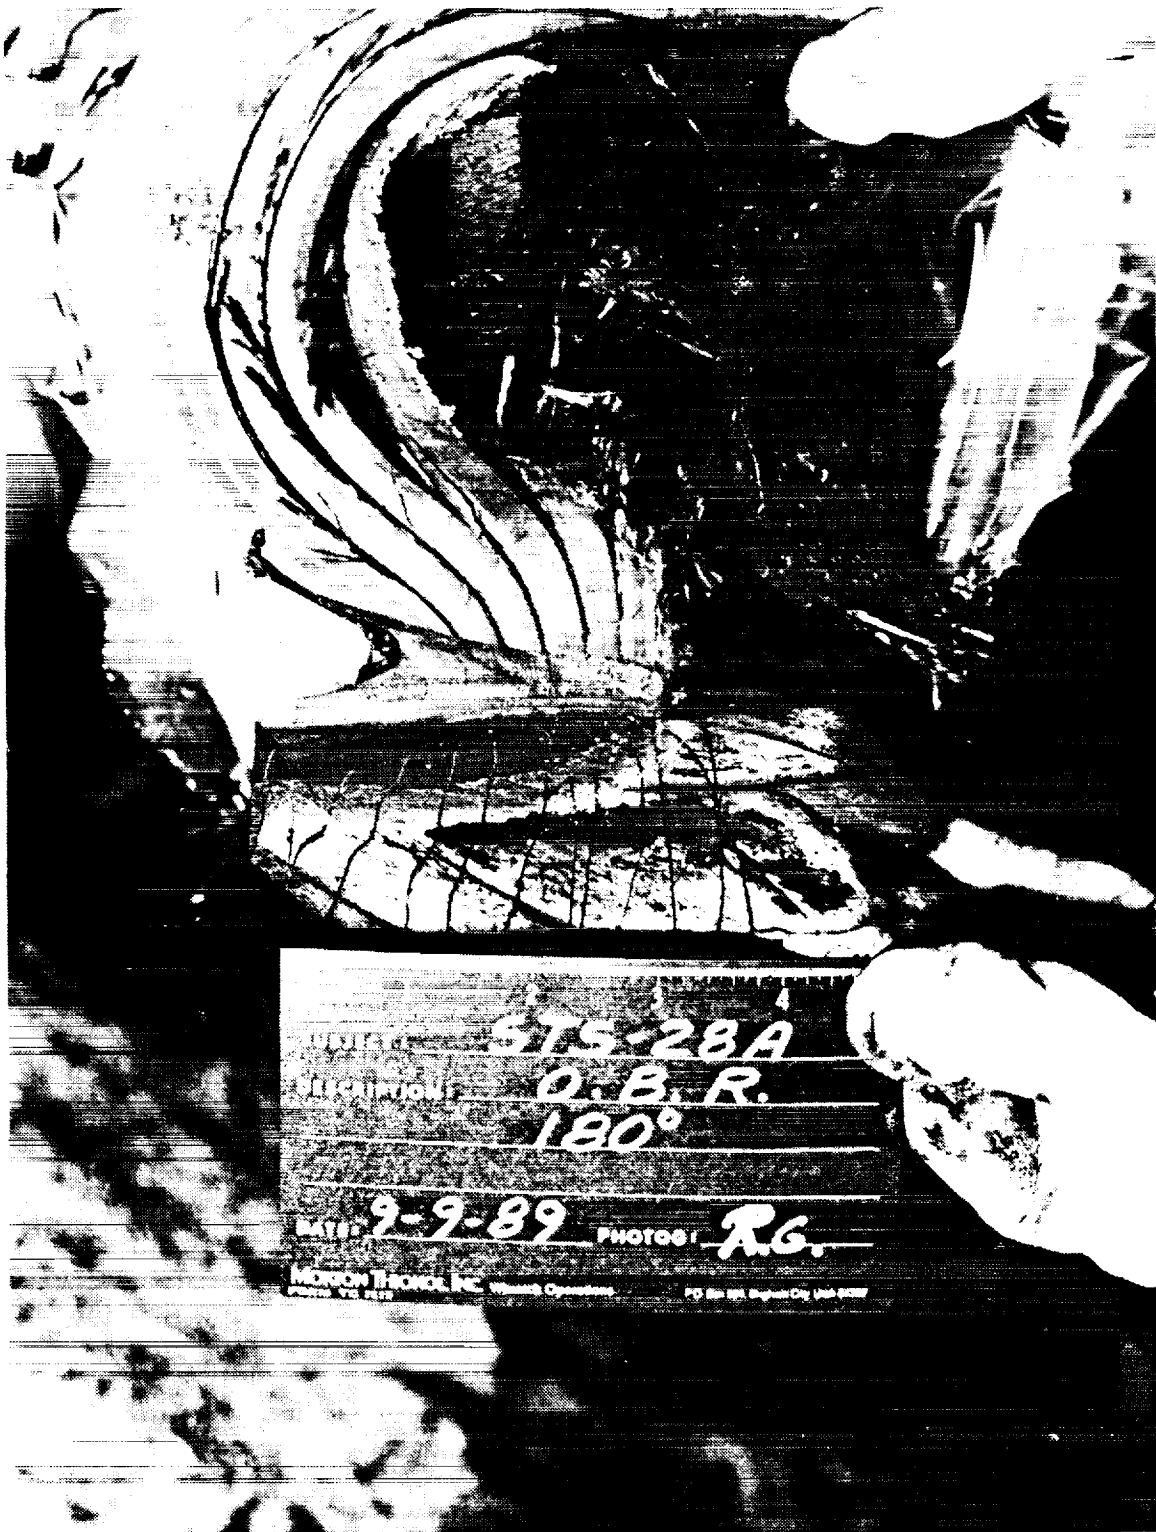
Photographs of the sectioned OBR are presented in Figures 39 through 42. Char and erosion analysis of the sections is presented in Table 6 (Stations 8 through 12). All margins of safety were positive, with a minimum of 0.48 occurring at station 11.3 (45 degrees).

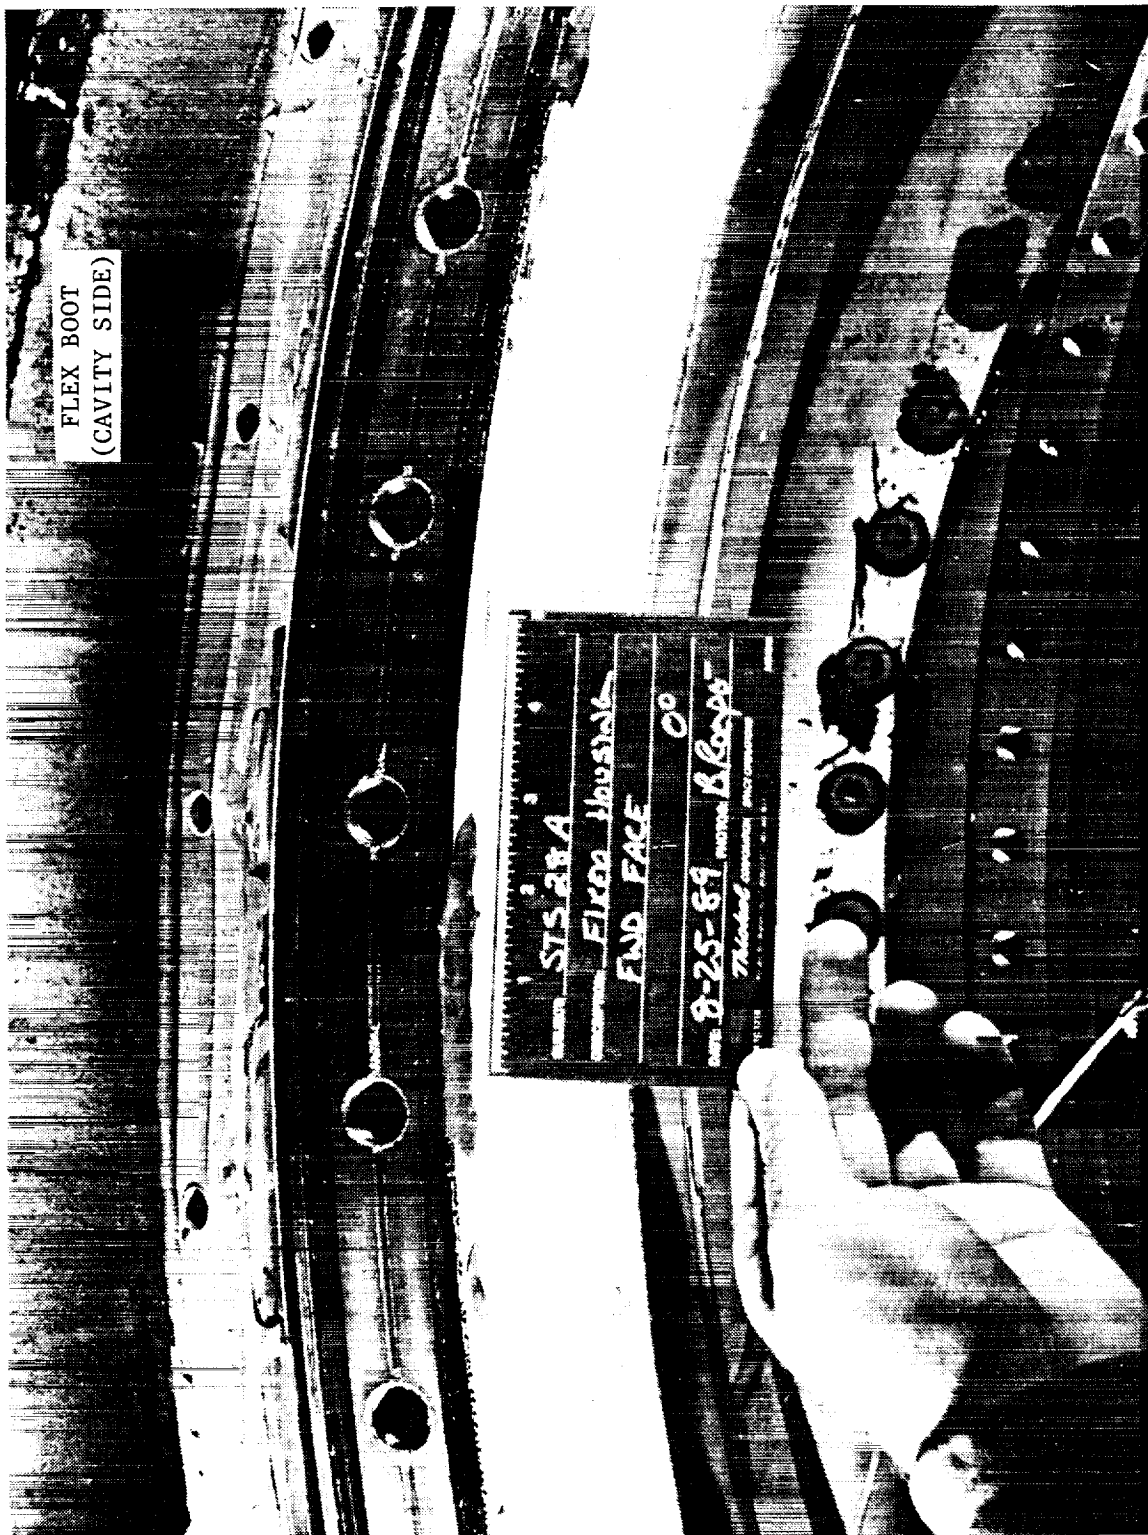
Figure 43 STS-28A Flex Boot (Cavity Side - 0 deg)

The flex boot remained attached to the outer boot ring 360 degrees circumferentially. The cavity side of the flex boot was evenly sooted and showed no evidence of flow or erosion (Figures 43 through 45). It appeared typical of previous flight and static test motor flex boots. A minimum of 3.25 NBR plies remained around the circumference after motor burn. Table 7 presents the flex boot material affected depths and Performance Margins of Safety (PMS). The worst-case PMS was 0.26 at 270 and 315 degrees.

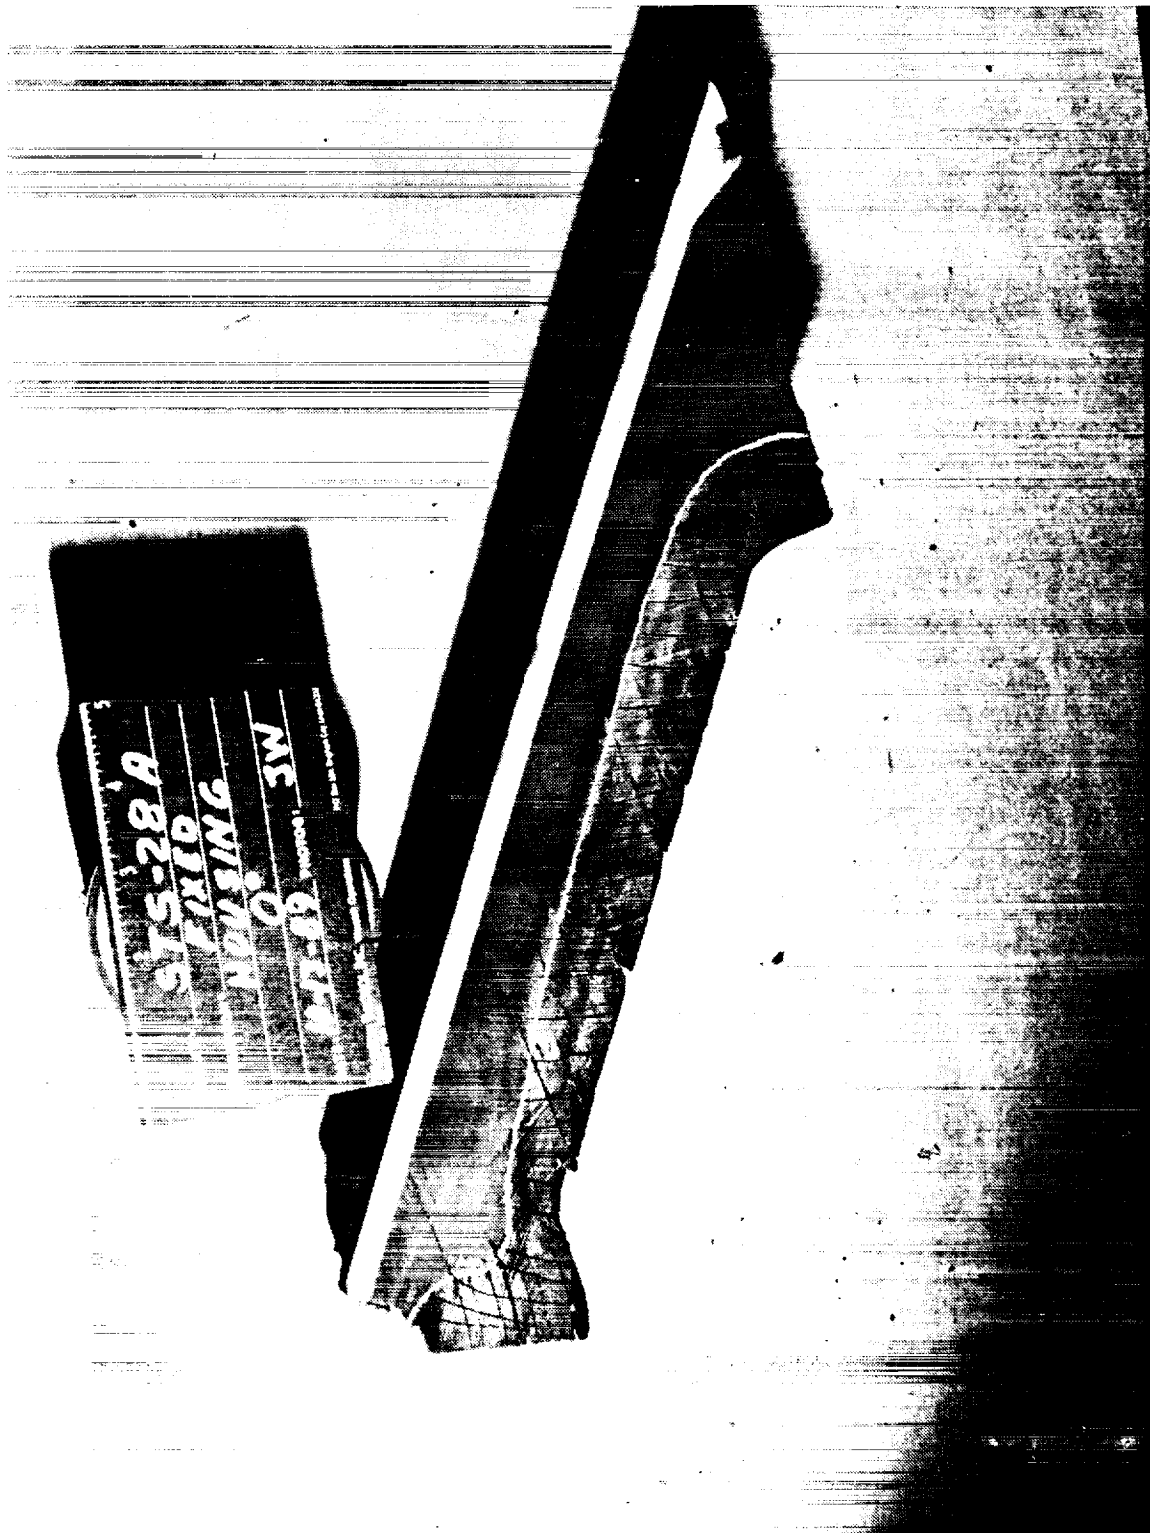
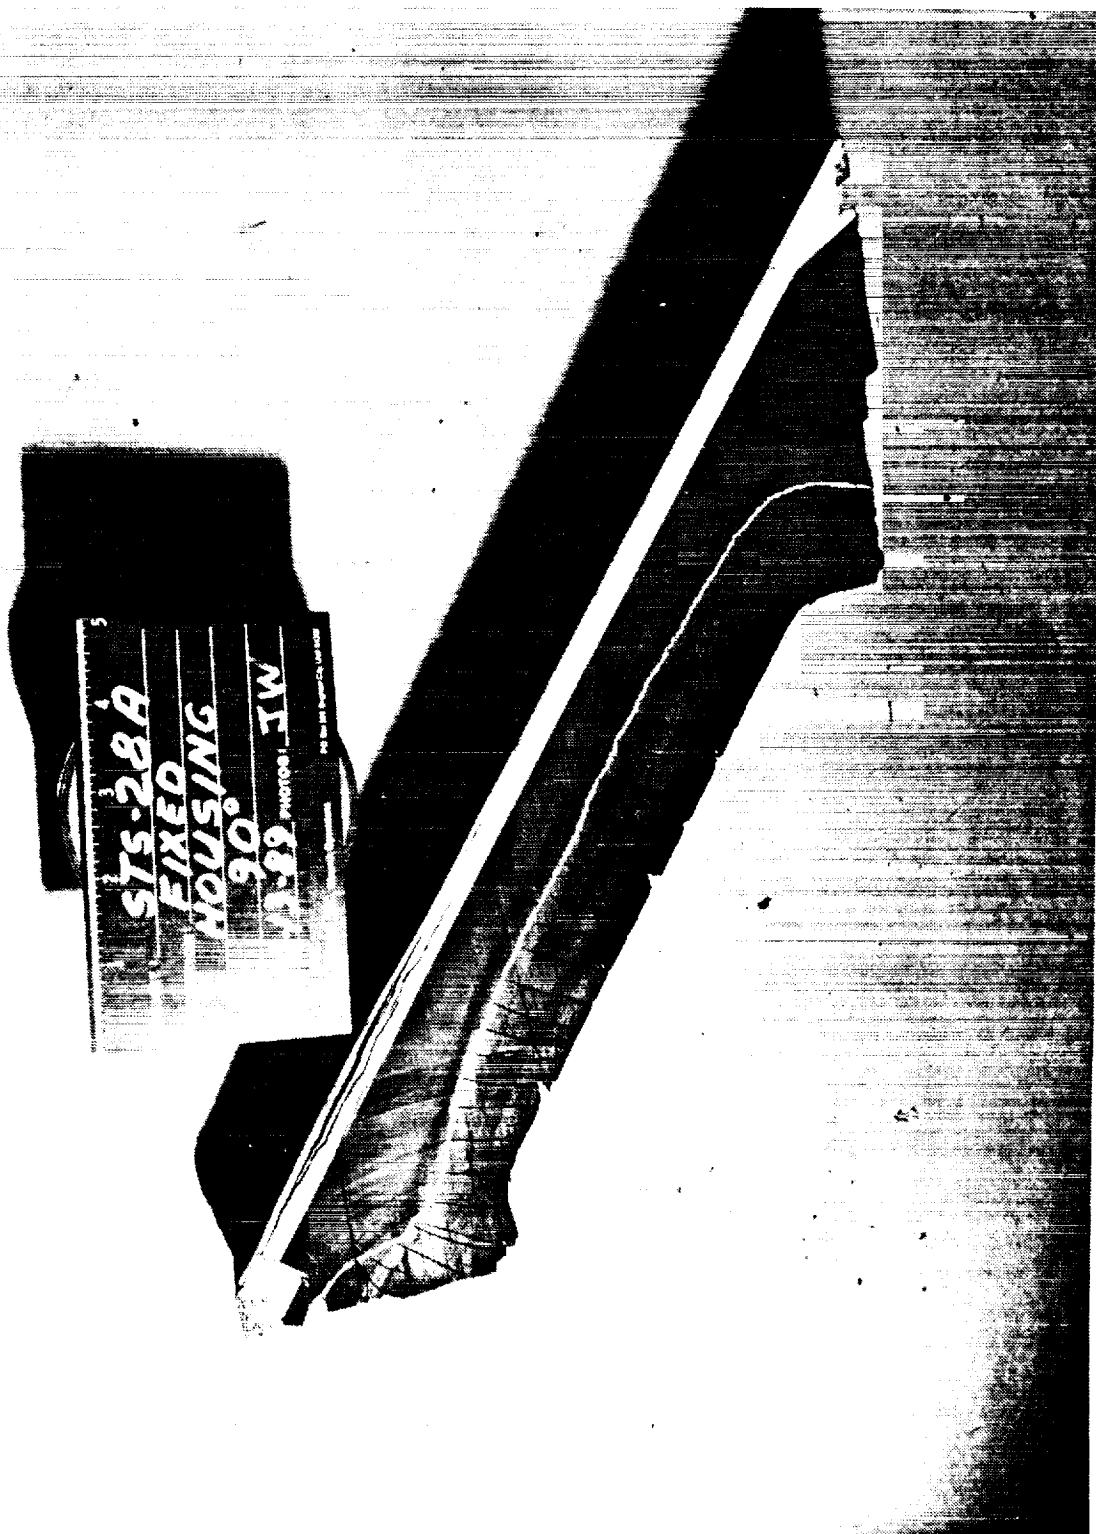
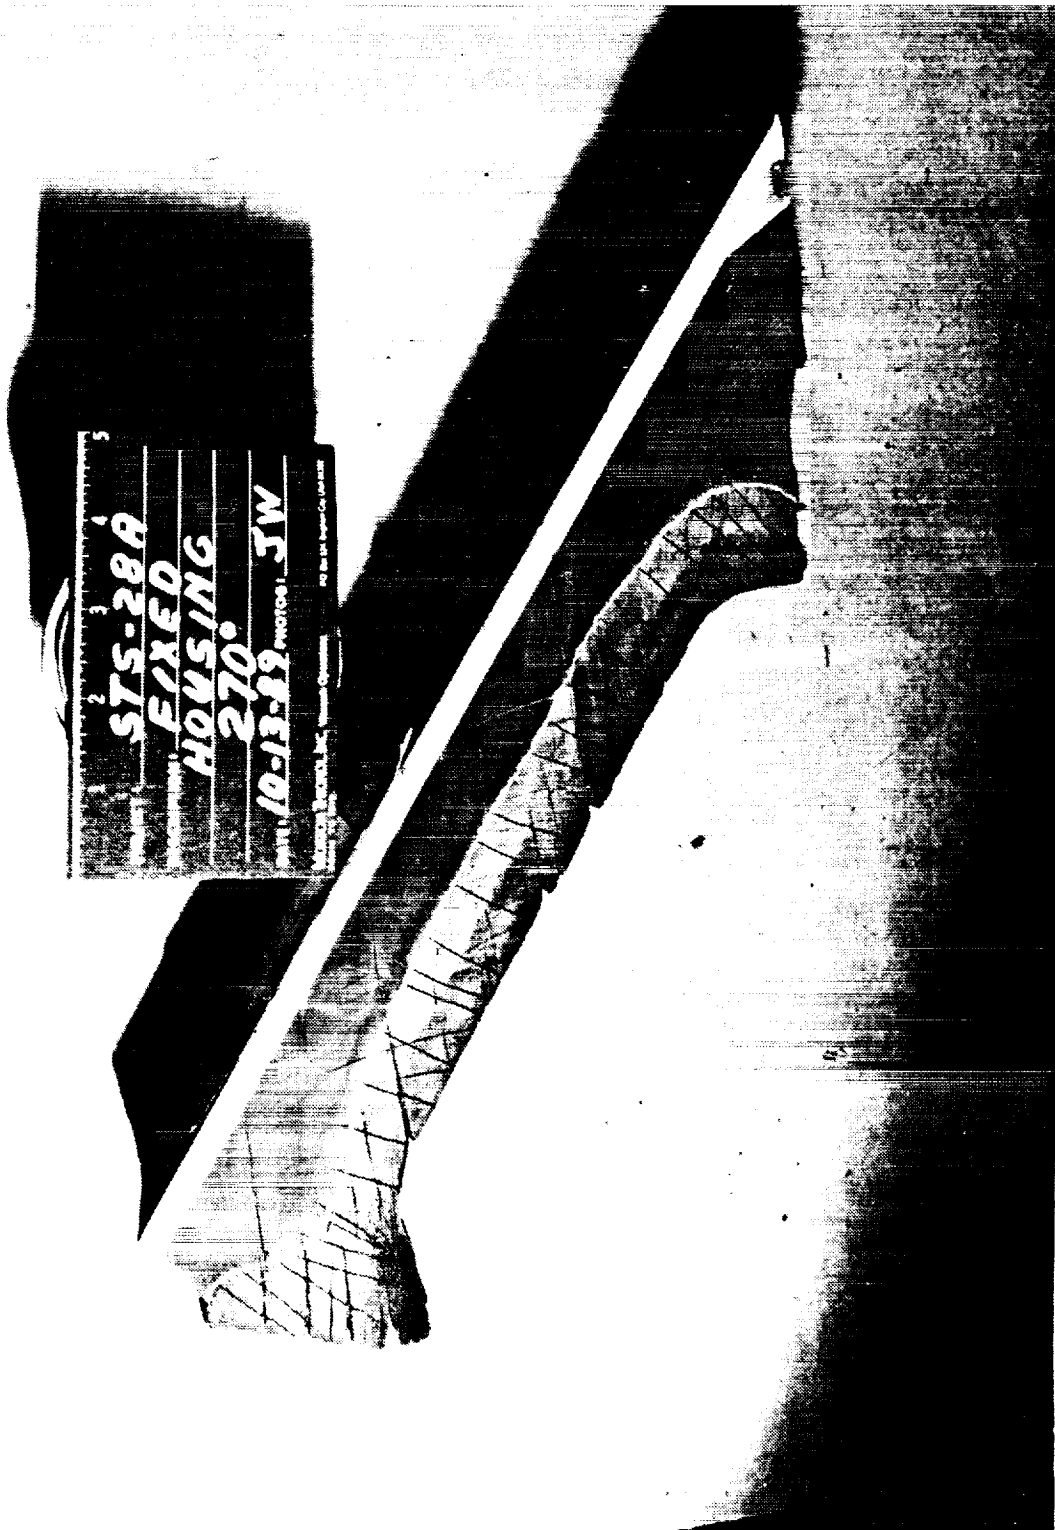
Photographs of the sectioned fixed housing assembly liner are presented in Figures 46 through 49. Char and erosion analyses of the sections are presented in Table 8. Figure 50 shows the location of the measurement stations. All margins of safety were positive, with a minimum of 0.52 occurring at station 3 (90 degrees).

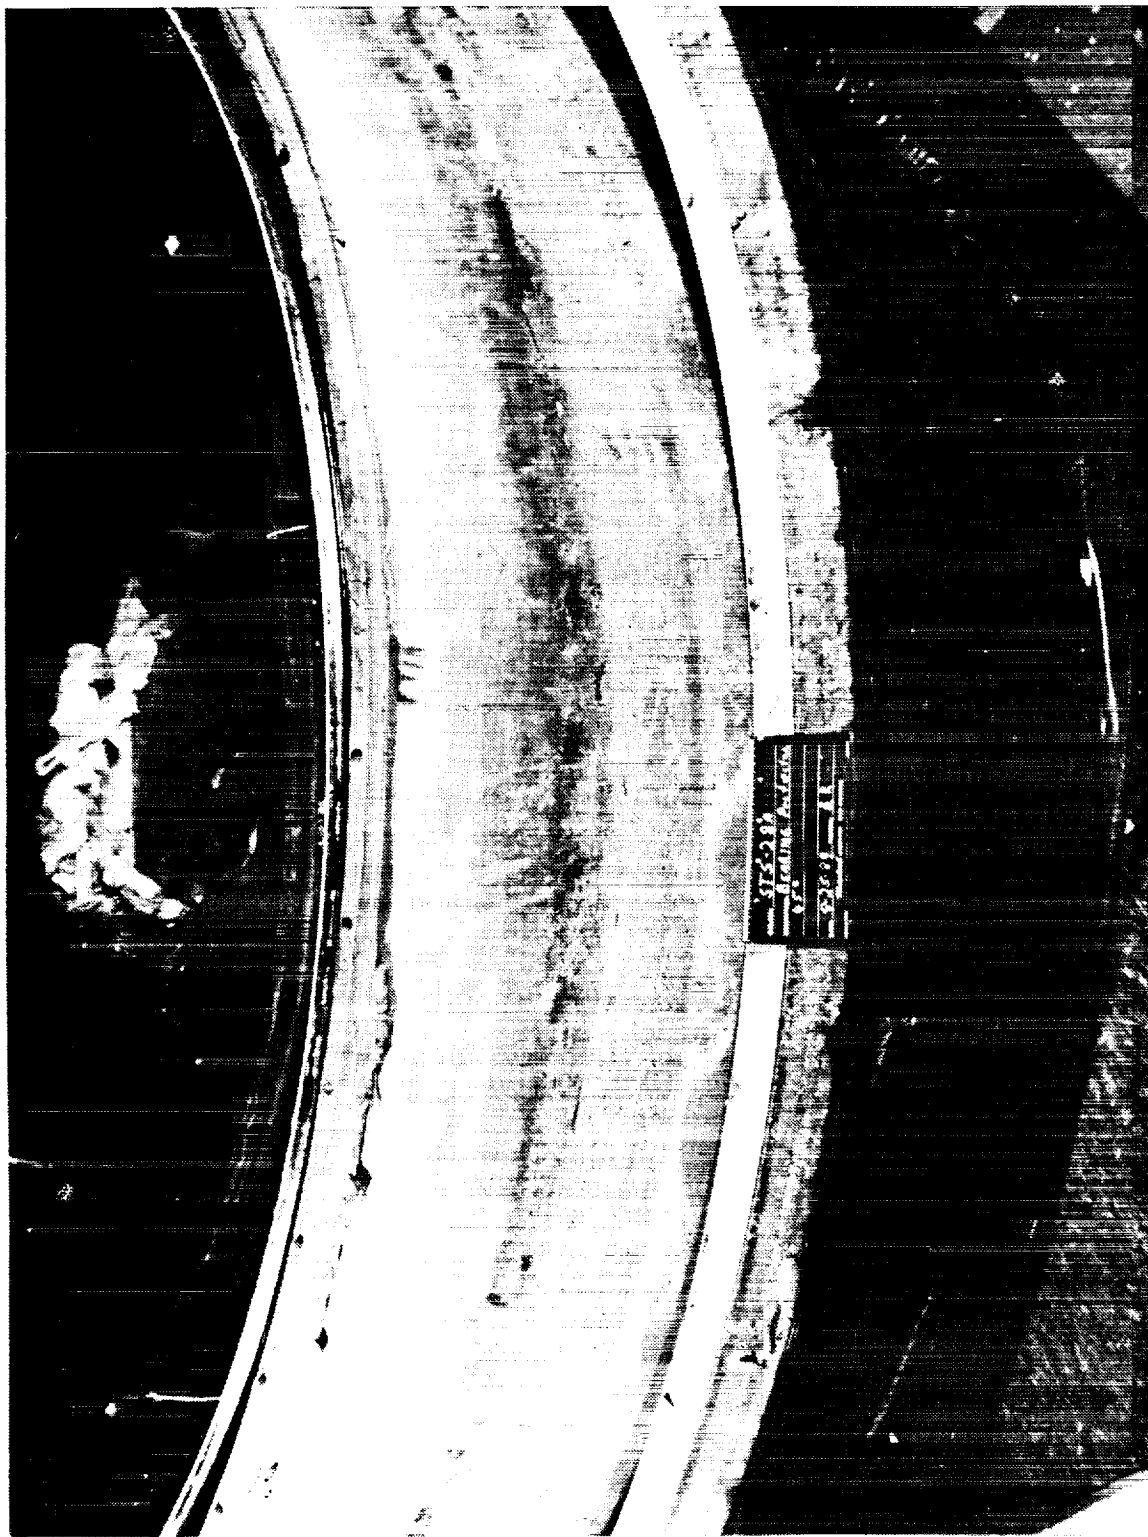
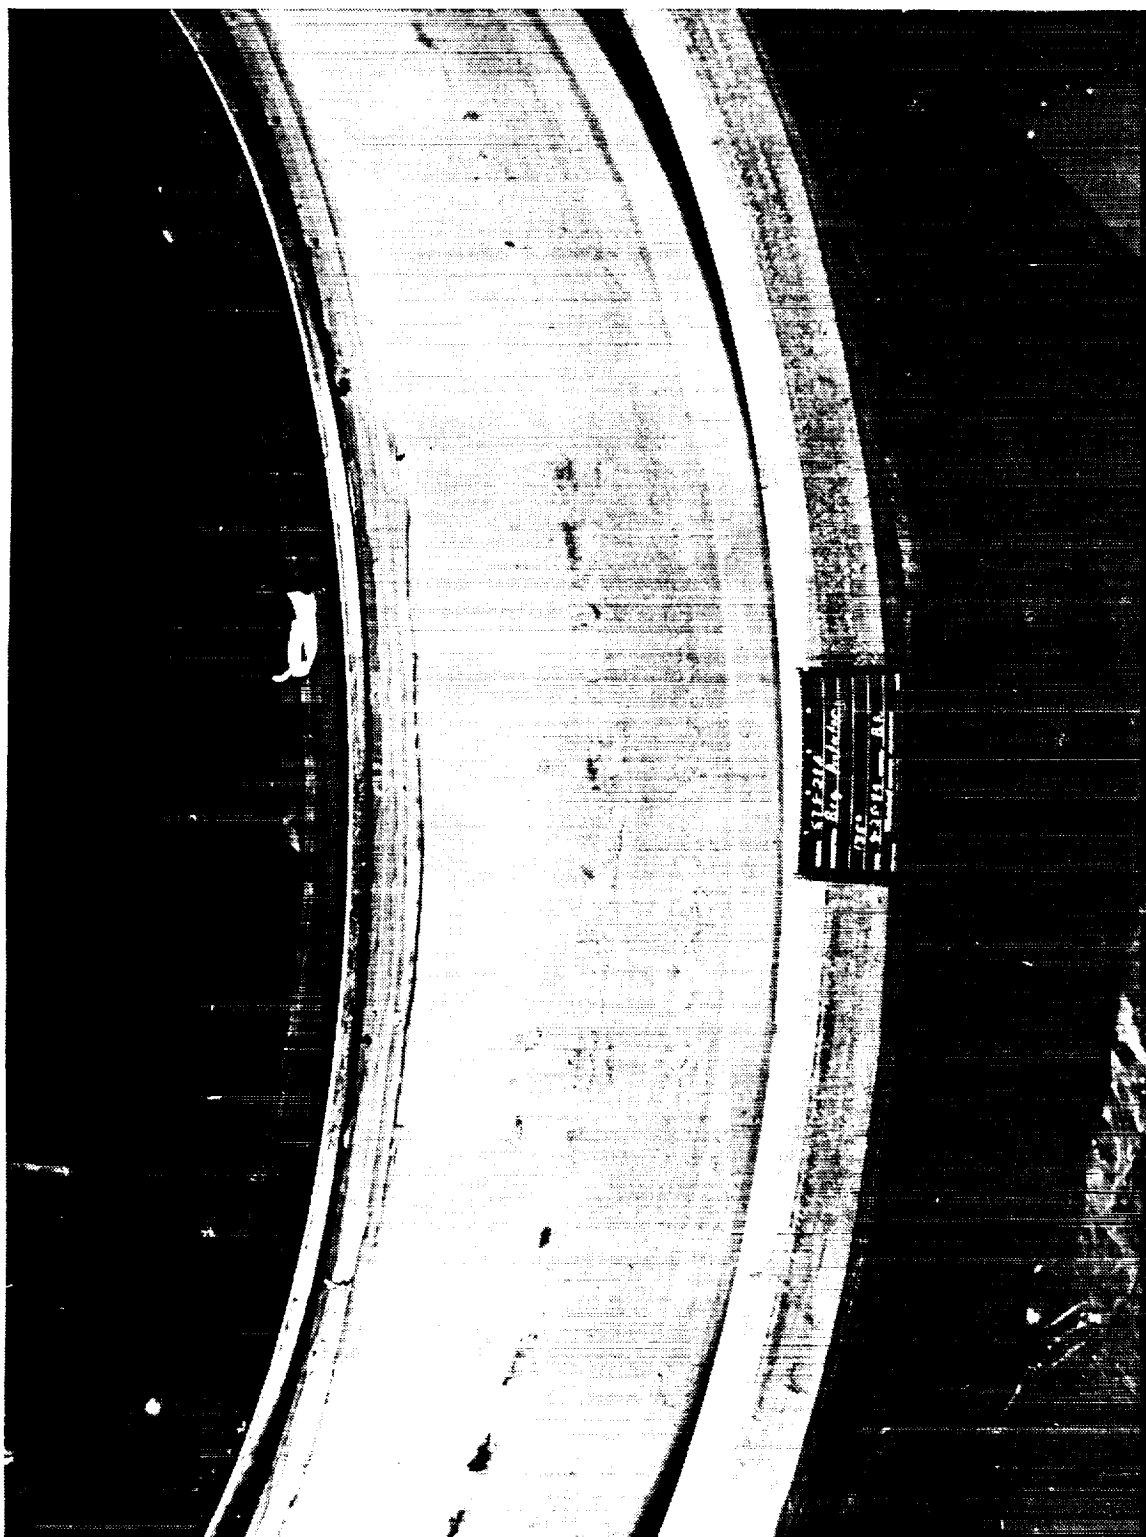
The bearing protector was sooted along the entire length and circumference (Figures 51 through 53). Slightly heavier soot and erosion were observed in line with the cowl ring vent holes at the thickened portion, but there was no bearing protector burn-through. The largest erosion was 0.162 inch at 90 degrees. There was no evidence of heat effect on the Inside Diameter (ID) surface of the bearing protector.
